**McGLELLAN AIR FORCE BASE**

**PREPARED BY:**  
Radian Corporation  
10395 Old Placerville Road  
Sacramento, California 95827

# OPERABLE UNIT B PRELIMINARY ASSESSMENT SUMMARY REPORT

**VOLUME III: APPENDICES C, D & E**

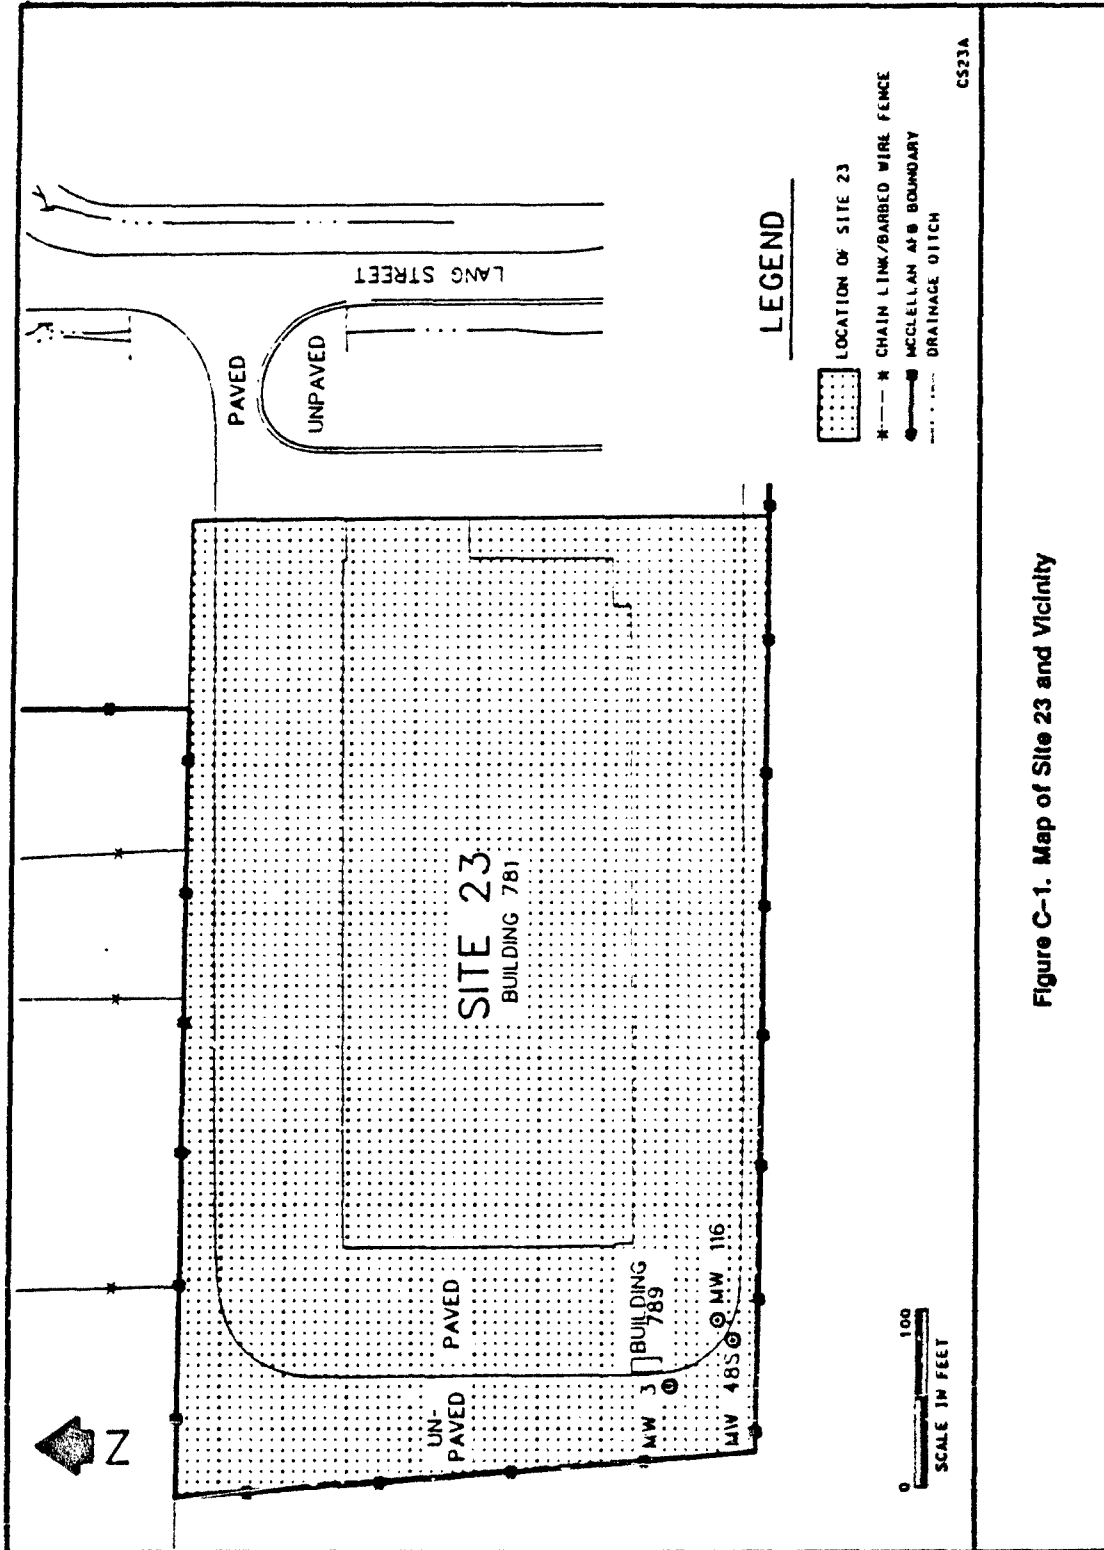
Figure C-1. Map of Site 23 and Vicinity

Odors, discolored soil, or buried debris were noted in 7 of the 10 borings. The odors were described as "slight solvent/sewage" odors. Debris and discolored soil was found to 24 feet BGS.

Inspect the water lines in the vicinity of Site 23 to determine if they are leaking. If leaks are found, they should be repaired to reduce further transport of contaminants in the soil. Collect and analyze additional soil samples to further characterize the extent of contamination.

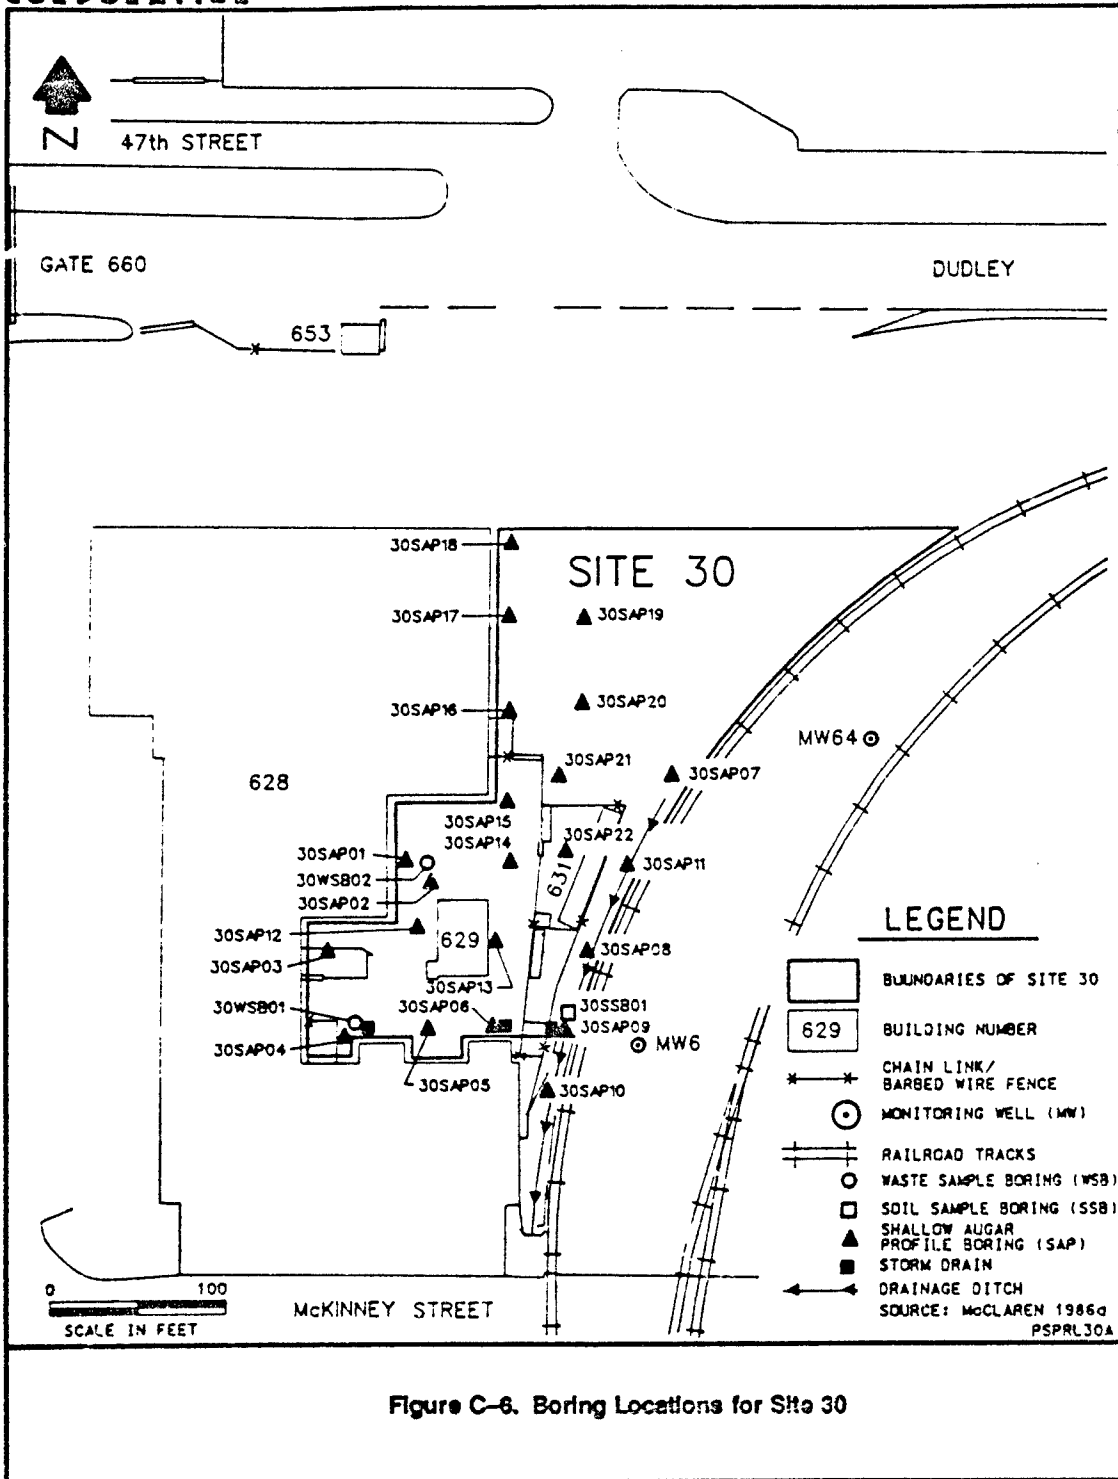
Figure C-6. Boring Locations for Site 30

Table C-2 lists the organic compounds detected in soil samples collected from Site 30.

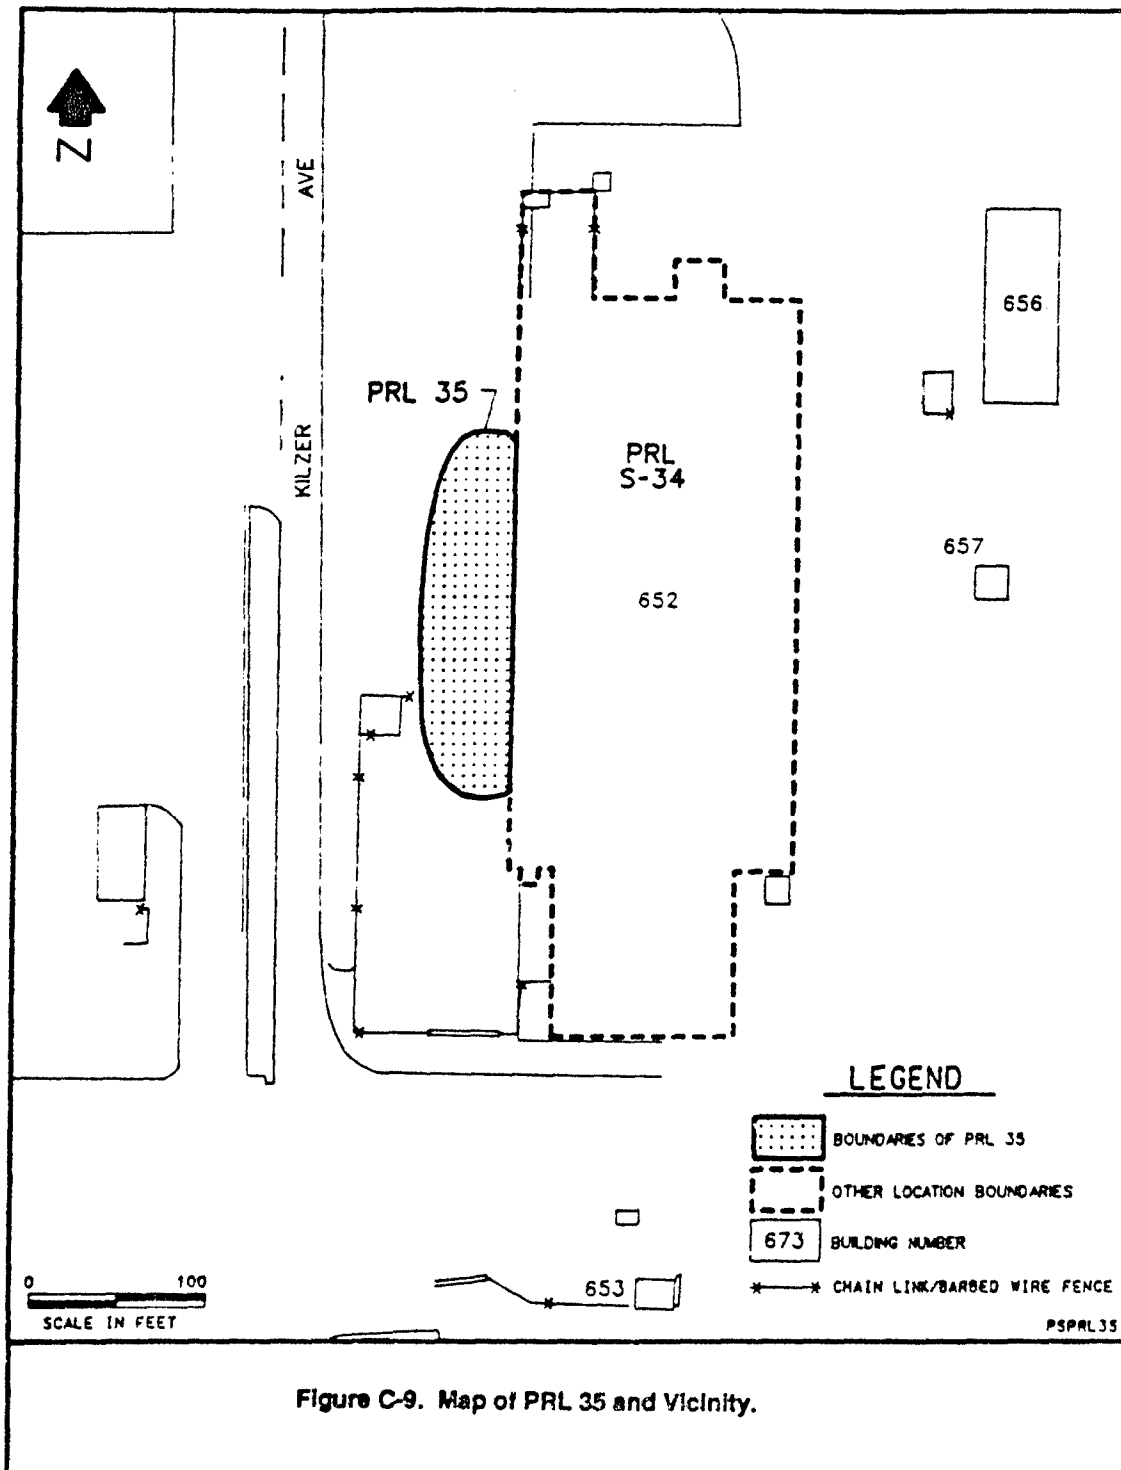
Figure C-9. Map of PRL 35 and Vicinity.

CH2M Hill reported scrap metal was buried during World War II near the present location of Building 652. No evidence supporting the existence of a burial pit has been found. Furthermore, there is no indication that hazardous materials were buried.

No further action is required because there is no evidence that hazardous materials were handled at the location.

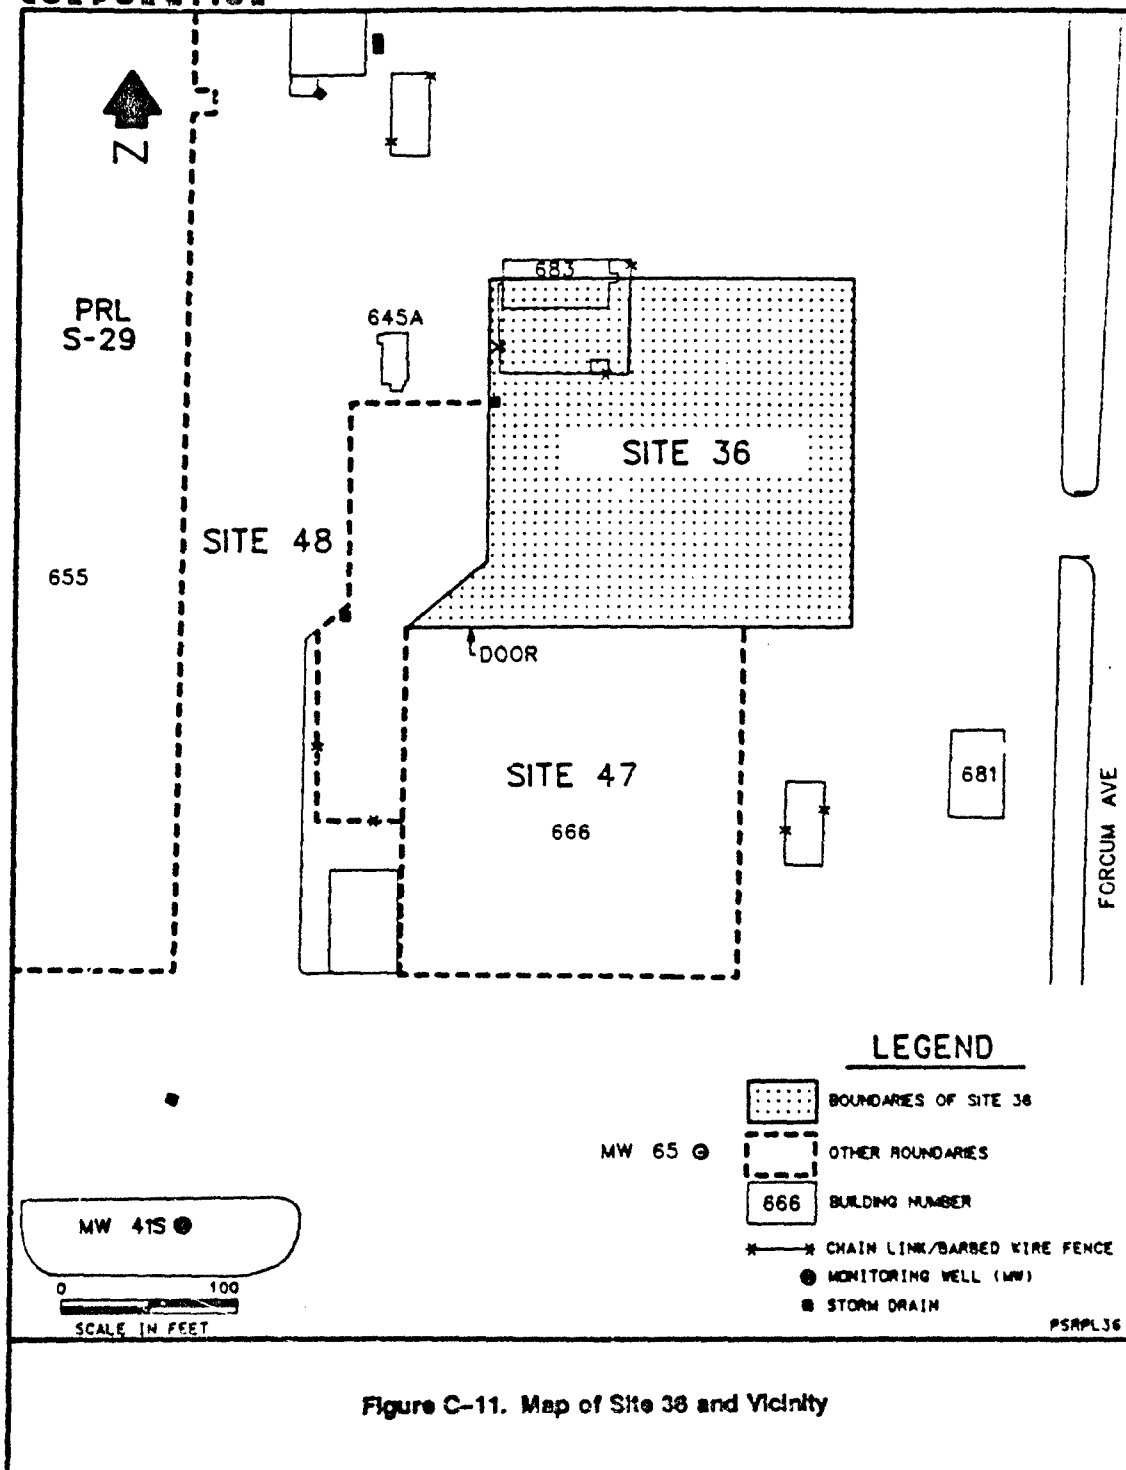
Figure C-11. Map of Site 36 and Vicinity

Discolored soil was noted between 3 and 7 feet BGS in Boring 48SAP03.

Collect and analyze near-surface soil samples for VOCs, semivolatile organic compounds, metals, and pH to further characterize the extent of contamination. Collect samples of the soil outside of the door on the north side of Building 666 to determine if contamination is present. Install an on-site monitoring well to determine if contaminants have migrated to groundwater. Conduct the RI of Site 36 and Sites 47 and 48 collectively.

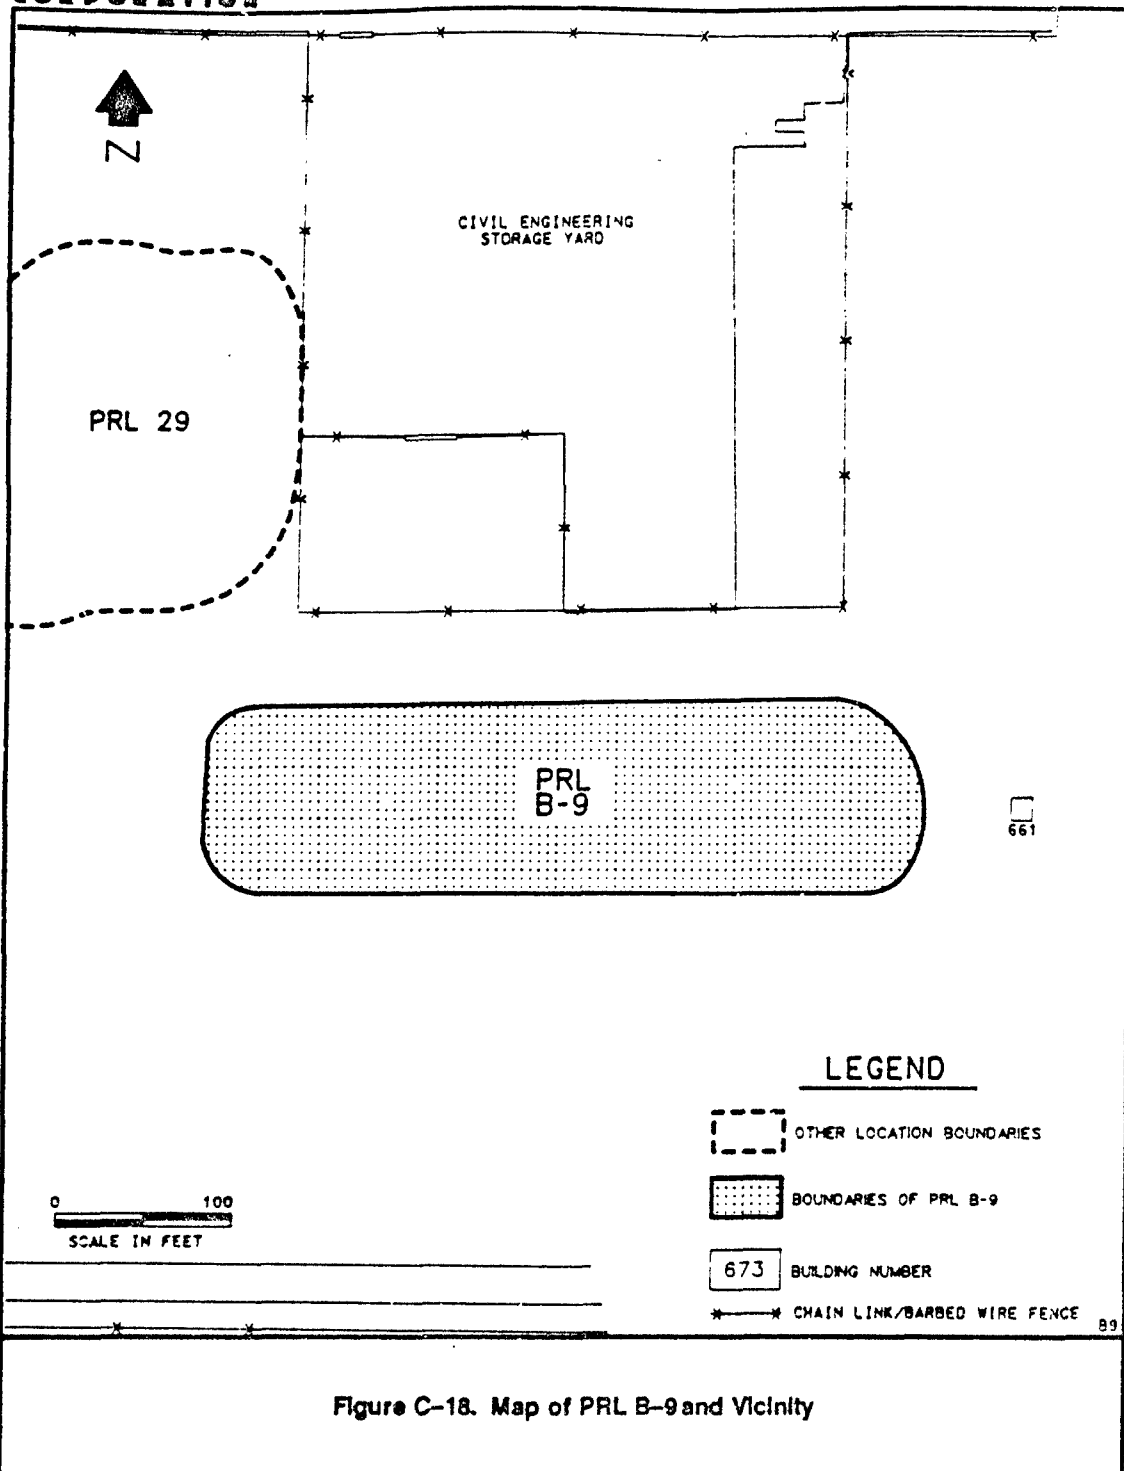
Figure C-18. Map of PRL B-9 and Vicinity

McClaren reported a burial pit may have existed at PRL B-9, based on their review of aerial photographs. No evidence has been found supporting the existence of a burial pit. Aerial photographs from the 1950s show no evidence of soil disturbance.

Remove from list of Potential Release Locations. No further action is required because there is no evidence a burial pit existed at the location and there is no indication that hazardous materials have been handled at the location.
